# NATIONAL TRANSPORTATION SAFETY BOARD

## MATERIALS LABORATORY FACTUAL REPORT

Report No. 05-109

Place : Wilmer, Texas  
Date : September 23, 2005  
Vehicle : MCI Motorcoach  
NTSB No. : HWY05MH035  
Investigator : Joseph Kolly

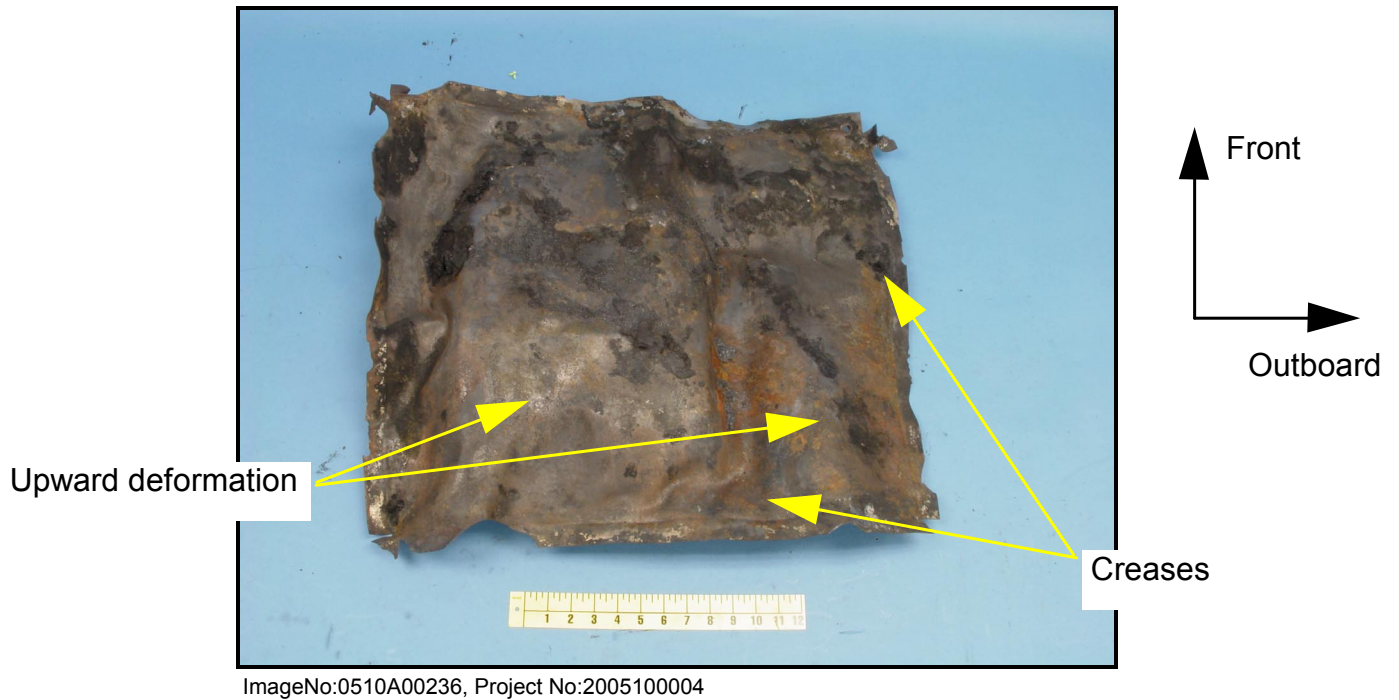
An overall view of the part submitted for examination is shown in figure 1. The steel panel measured approximately 23.5 inches (front to back) by 26.5 inches (side to side) by 0.05 inch thick. A 1-inch lip had been folded up at 90° around all four sides, and the folded panel had been welded to the bus frame at four locations along each edge. The length of each weld was approximately 1.5 to 2 inches. The panel had originally been installed in a horizontal orientation within the frame of the bus above the tandem right rear drive wheels.

The panel was generally oxidized, discolored and covered in soot. The top surface of the panel had some areas of rust and retained remnants of some material that appeared to be insulation.

The panel had two areas of upward deformation running from front to back, separated by a downward crease approximately 3 inches wide and 2 inches deep. The inboard area of upward deformation was roughly cylindrical in shape, being broadly curved front to back and sharply bounded inboard and outboard. The inboard area of upward deformation was approximately 12 inches wide, and its inboard boundary was approximately 4 inches from the inboard edge of the panel; the deformation was approximately 2 inches high at its maximum. The outboard area of upward deformation extended from the front to back crease to the outboard edge of the panel. This upward deformation was approximately 1 inch high at maximum, and was also roughly cylindrical, but less well defined. A shallow downward crease approximately 2 inches wide 1 inch deep ran left to right through this outboard upward deformation; the front edge of this crease was approximately 7 inches back from the front edge of the panel. The folded lips

All of the fracture features at the locations of the sixteen welds were consistent with tensile overstress separations. Seven of the fractures appeared to be limited to lie along the edges of the welds, possibly within the heat affected zones. Five additional fractures separated along the weld boundaries, but had partial tears extending into the panel. Four of the fractures propagated through the panel itself, leaving roughly triangular pieces of the panel still welded to the frame of the bus. These triangular pieces remained on the motorcoach and were photographed, and shown to be oriented outward from the surface of the frame at an angle of approximately 30°.

Figure 1. Top surface of the floor panel submitted for examination.

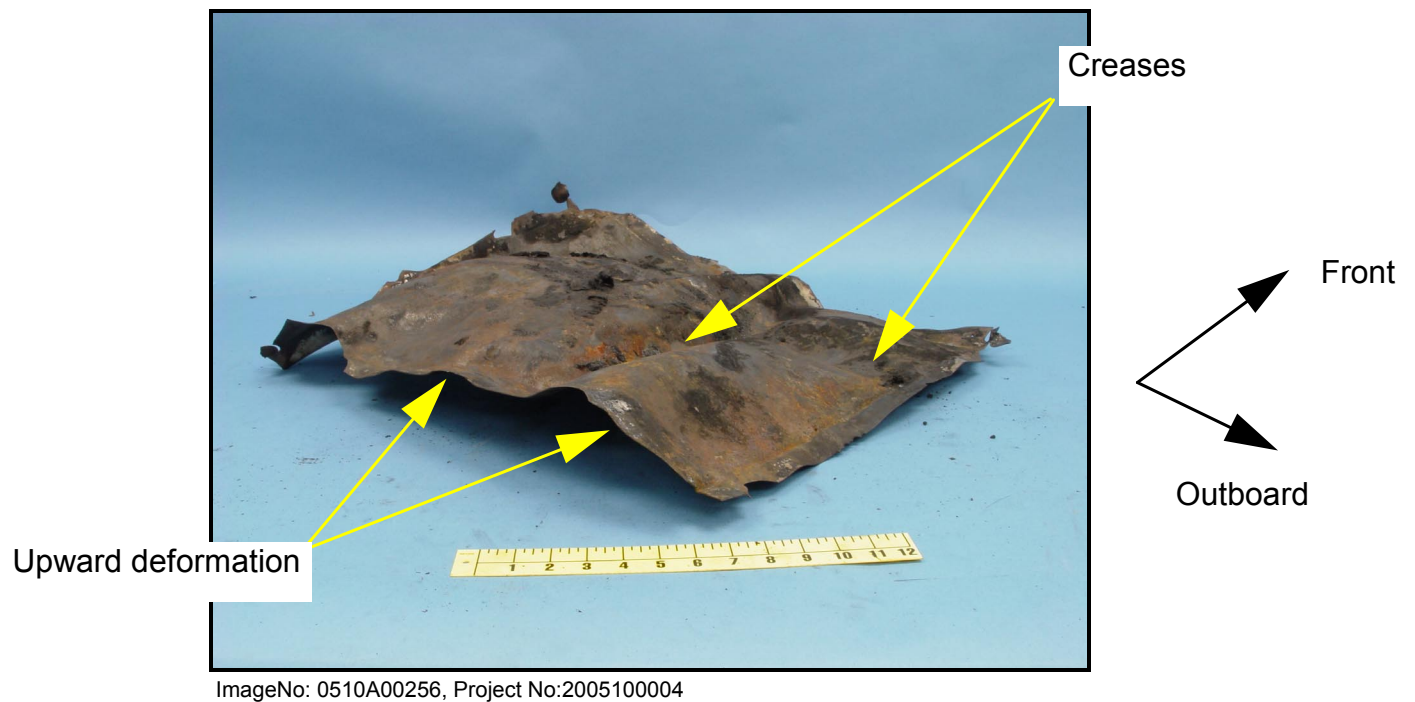
along all four edges of the panel had been substantially straightened, as can be seen in figure 2.

Figure 2. Oblique view of the top surface of the panel. The folded lips along all four edges have been largely straightened.
